Pines Subdivision

January 12, 2016

Issue

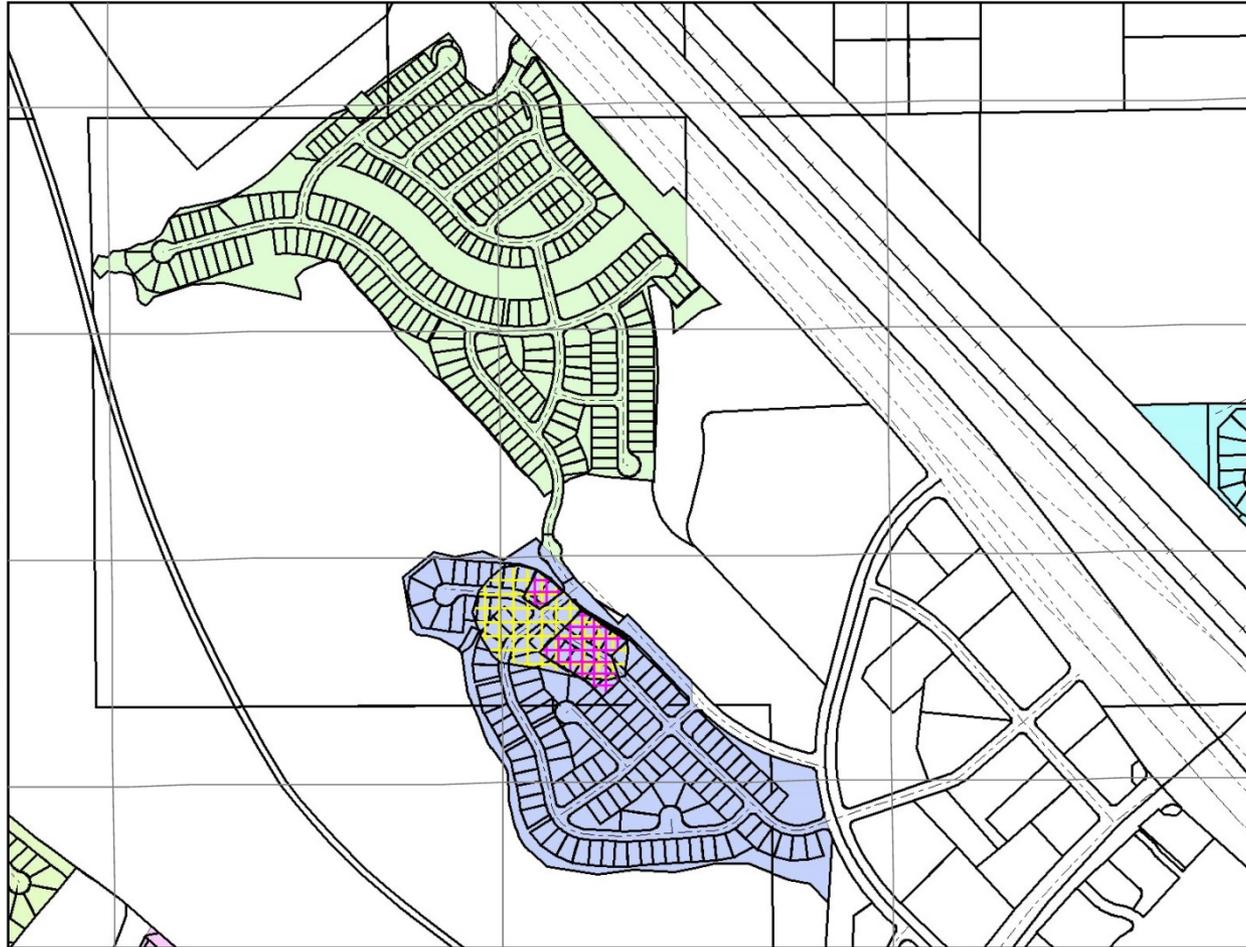
Greater Area

- Due to an isolated area of poorly compacted fills during operations of a former sand and gravel pit, an area within the Pines 1 subdivision has experienced significant settlement.
- The Town in conjunction with Richmond American Homes is working to resolve the issue.

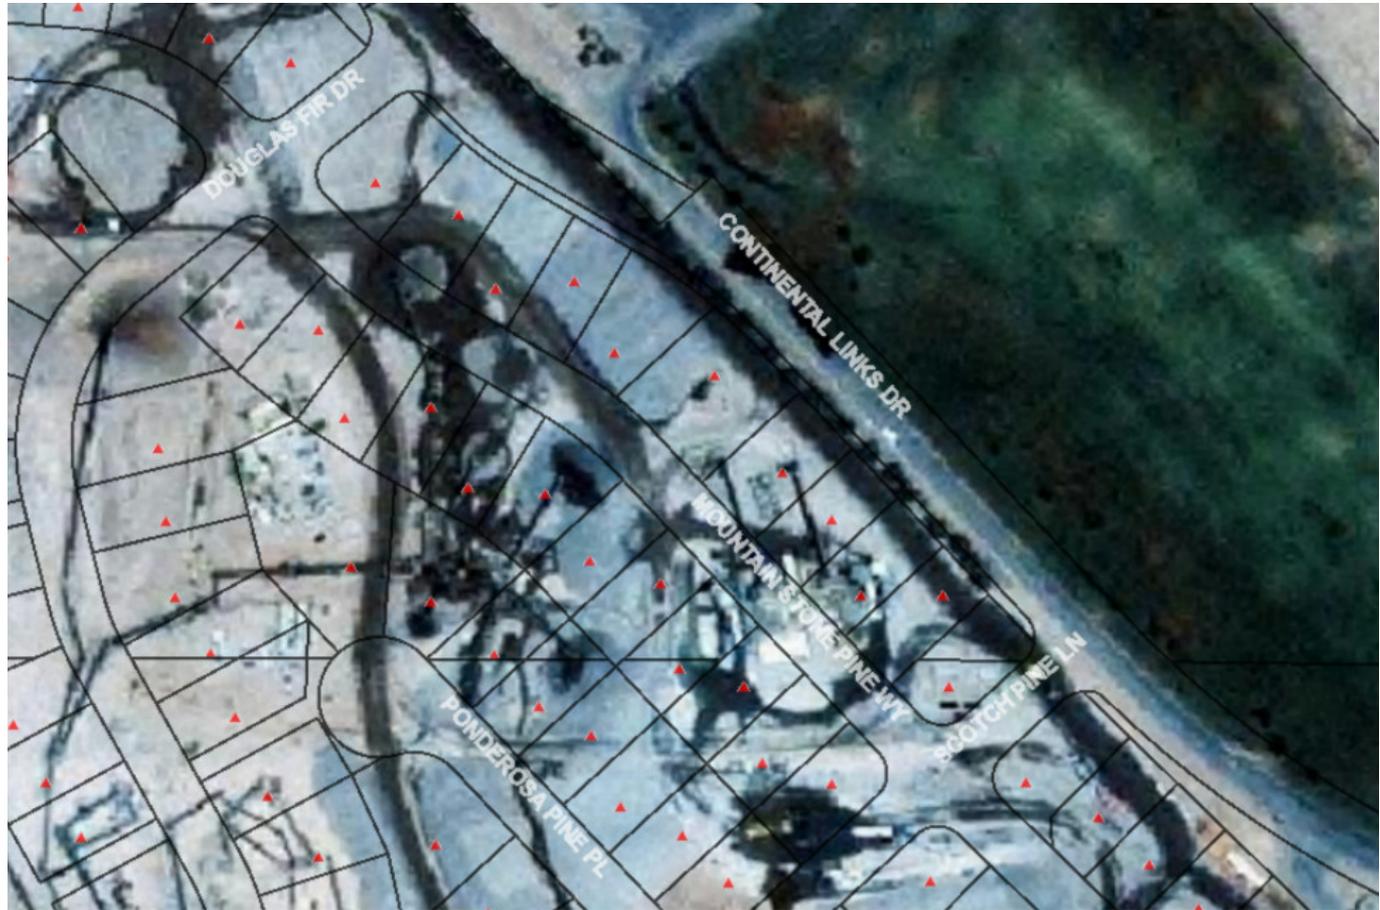
1978 imagery

Prior Operations
